## SignalLink™ USB - RF Interference Fix

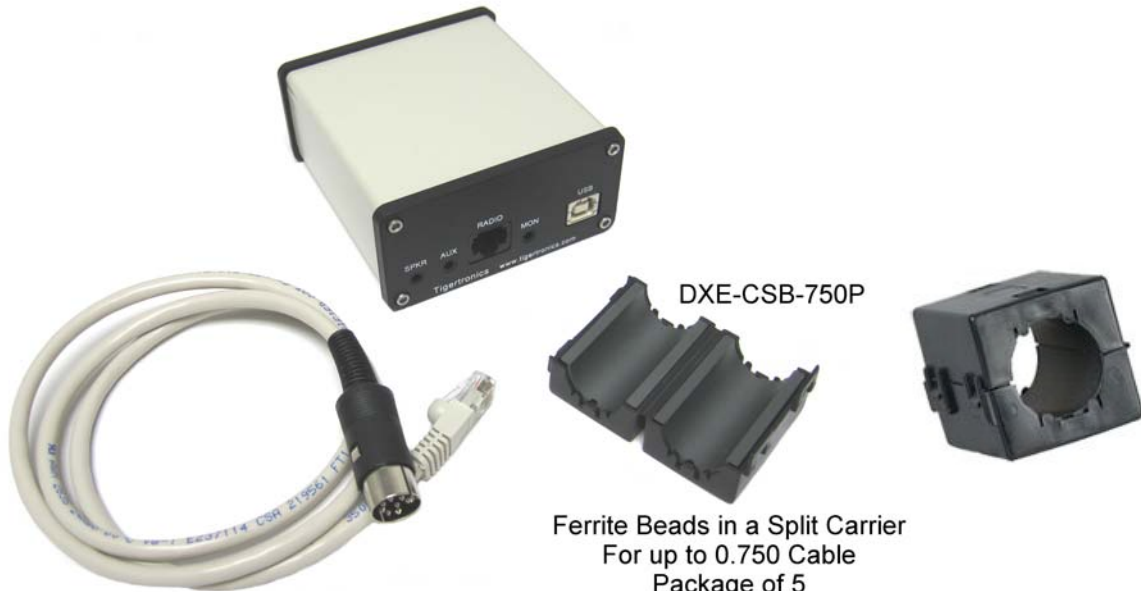
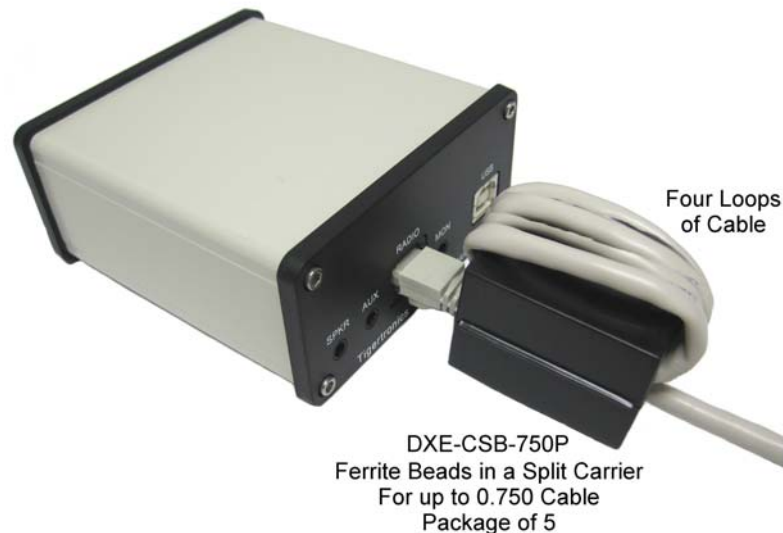
It has been reported when using the Tigertronics SignalLink™ USB unit in a very high RF environment, some RF may work its way into the SignalLink™.

July 2008 - Problem Reported: Icom 756 Pro III, RTTY, 1.5 kW power. Your results may vary.

The easy fix is to install one DX Engineering **DXE-CSB-750P** Ferrite Bead on the cable (four loops of cable through the Ferrite Bead) running from your radio to the SignalLink™ USB radio input. The addition of this ferrite bead cured the reported problem.
